Borehole BH-3 – Access Road (Pavement Thickness: 0.5 m + Subgrade: 0.5 m)

FINAL BOREHOLE LOG AND SUMMARY OF TEST RESULTS																							
PROJECT:		Geotechnical Investigation for the Proposed New Bohol Airport Construction & Sustainable Environmental Protection Project						HOLE NO.:		BH-4													
LOCATION:		Panglao, Bohol						DEPTH:		5.0 m													
DATE DRILLED:		2/26/2013		DATE FINISHED:		2/26/2013		WATER TABLE:				DWT											
DEPTH, m	SAMPLE NUMBER	% RECOVERY	% RQD	SAMPLE TYPE	LOG SYMBOL	UNIFIED CLASSIFICATION	DESCRIPTION	N-VALUES			MOISTURE CONTENT	ATTERBERG LIMITS		SIEVE ANALYSIS % PASSING SIEVE NO.									
								SPT	GRAPH			LL (%)	PI (%)	110	100	75	60	40	20	15	7.5	4.75	
							Ground Surface	15 cm	15 cm	15 cm													
1	1	44	-	SS	SS	GM	Light brown, very dense silty gravel with sand (broken corals with limestone) of no plasticity	29	27	46	8.42	NP	NP	100	75	54	37	28	21	16			
2	2	67	-	SS	SS	GM	Light brown, very dense silty gravel with sand (broken corals with limestone) of no plasticity	30	27	48	9.07	NP	NP	100	88	76	64	49	37	26	20

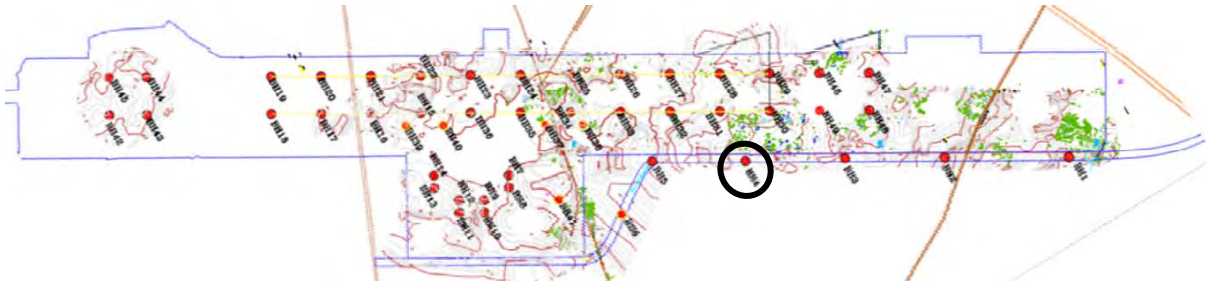
Borehole BH-4 – Access Road (Pavement Thickness: 0.5 m + Subgrade: 0.5 m)

Existing Grade: 8.3 m Finished Grade: 9.2 m Subgrade Elevation: 8.2 m Cut height: 0.1 m

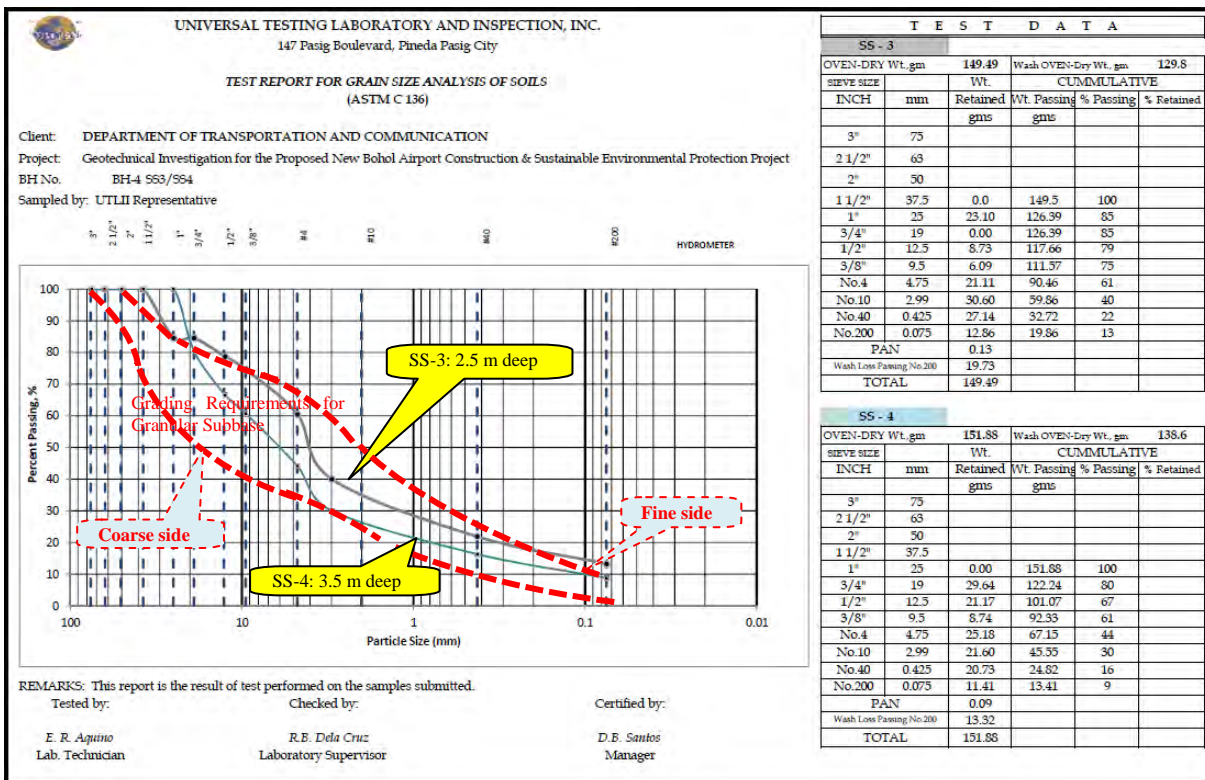
Borehole BH-4 – Access Road (Pavement Thickness: 0.5 m + Subgrade: 0.5 m)

No fine topsoil exists. No large cavity exists.

Natural soil at subgrade level generally meets gradation of granular subbase course when blending with small amount of crashed limestone fragment.

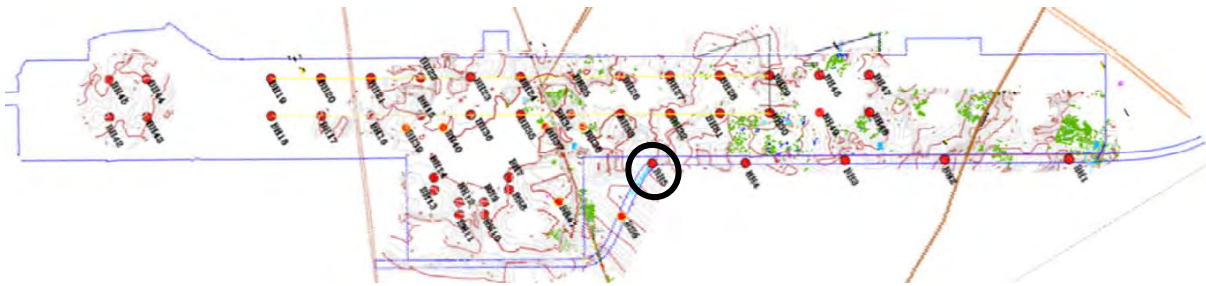
Borehole BH-5 – Access Road (Pavement Thickness: 0.5 m + Subgrade: 0.5 m)

Existing Grade: 9.0 m Finished Grade: 8.8 m Subgrade Elevation: 7.8 m Cut height: 1.2 m

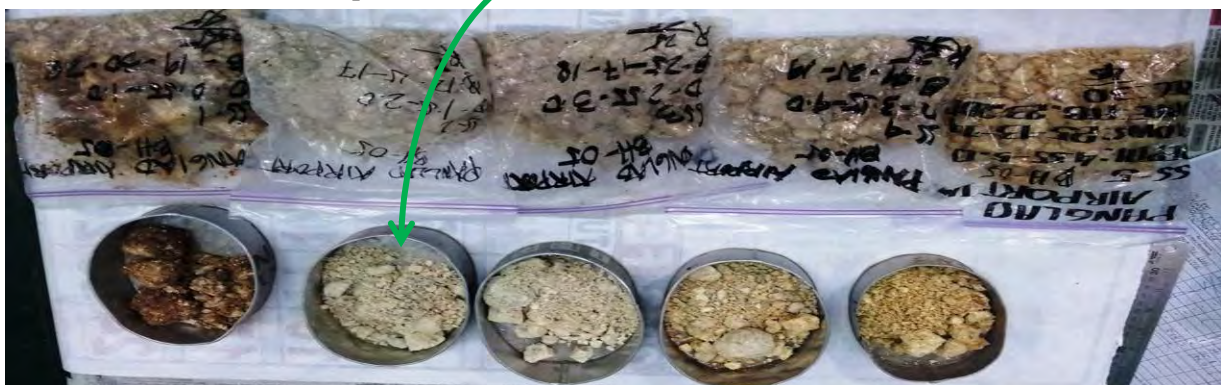
Pictures of disturbed soil samples

Location	SS1	SS2	SS3	SS4	SS5
Can Number	1	2	3	4	5
Weight of can & wet soil, g.	219.33	155.91	192.94	227.99	198.51
Weight of can & dry soil, g.	179.42	144.64	180.58	211.37	181.26
Weight of water, g.	39.91	11.27	12.36	16.62	17.25
Weight of can, g.	25.49	25.89	25.68	25.48	17.11
Weight of dry soil, g.	153.93	118.75	154.90	185.89	164.15
Moisture Content, %	25.93	9.49	7.98	8.94	10.51

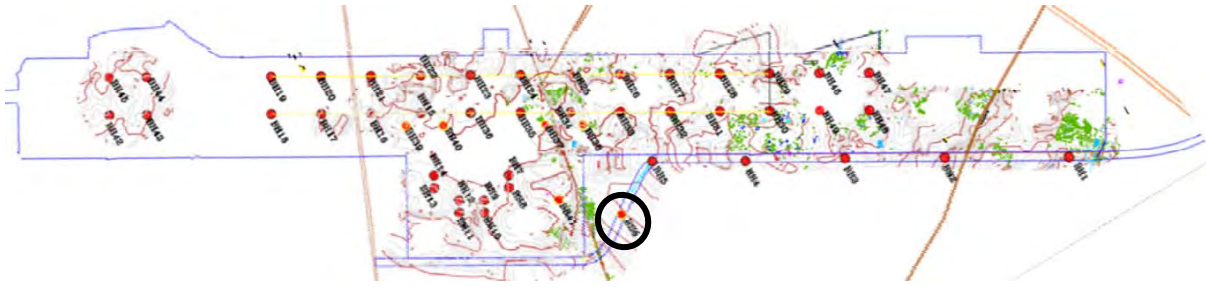
Borehole BH-6 – Access Road (Pavement Thickness: 0.5 m + Subgrade: 0.5 m)

Existing Grade: 7.4 m Finished Grade: 8.5 m Subgrade Elevation: 7.5 m Fill height: 0.1 m

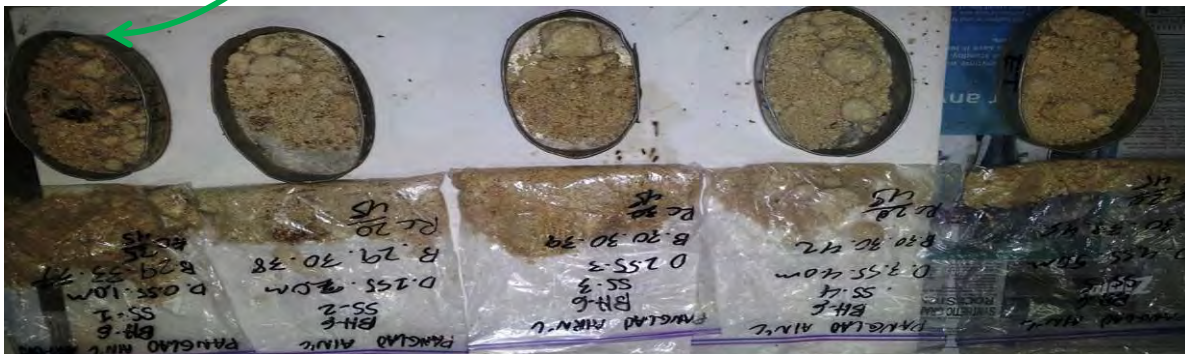
Pictures of disturbed soil samples

Location	SS1	SS2	SS3	SS4	SS5
Can Number	1	2	3	4	5
Weight of can & wet soil, g.	168.84	122.82	142.75	120.77	136.57
Weight of can & dry soil, g.	152.89	114.46	124.13	111.17	127.22
Weight of water, g.	15.95	8.36	18.62	9.60	9.35
Weight of can, g.	17.10	18.88	18.62	16.95	17.56
Weight of dry soil, g.	135.79	95.58	105.51	94.22	109.66
Moisture Content, %	11.75	8.75	17.65	10.19	8.53

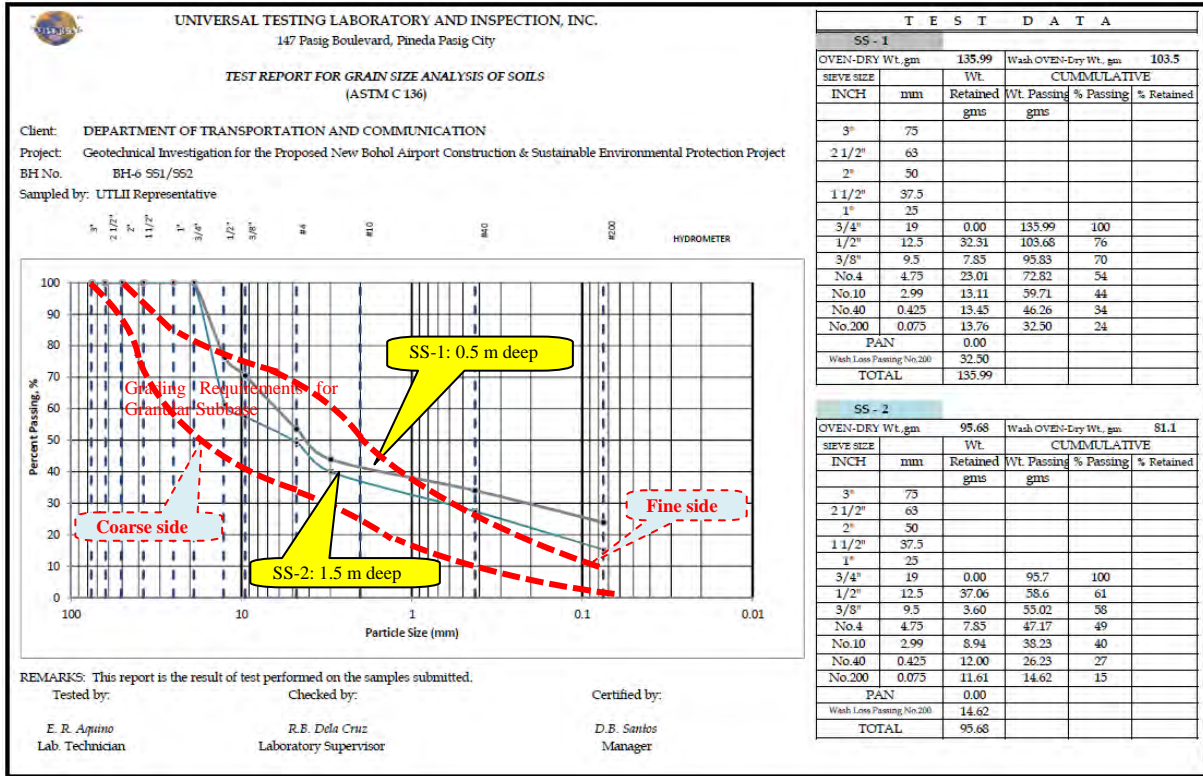
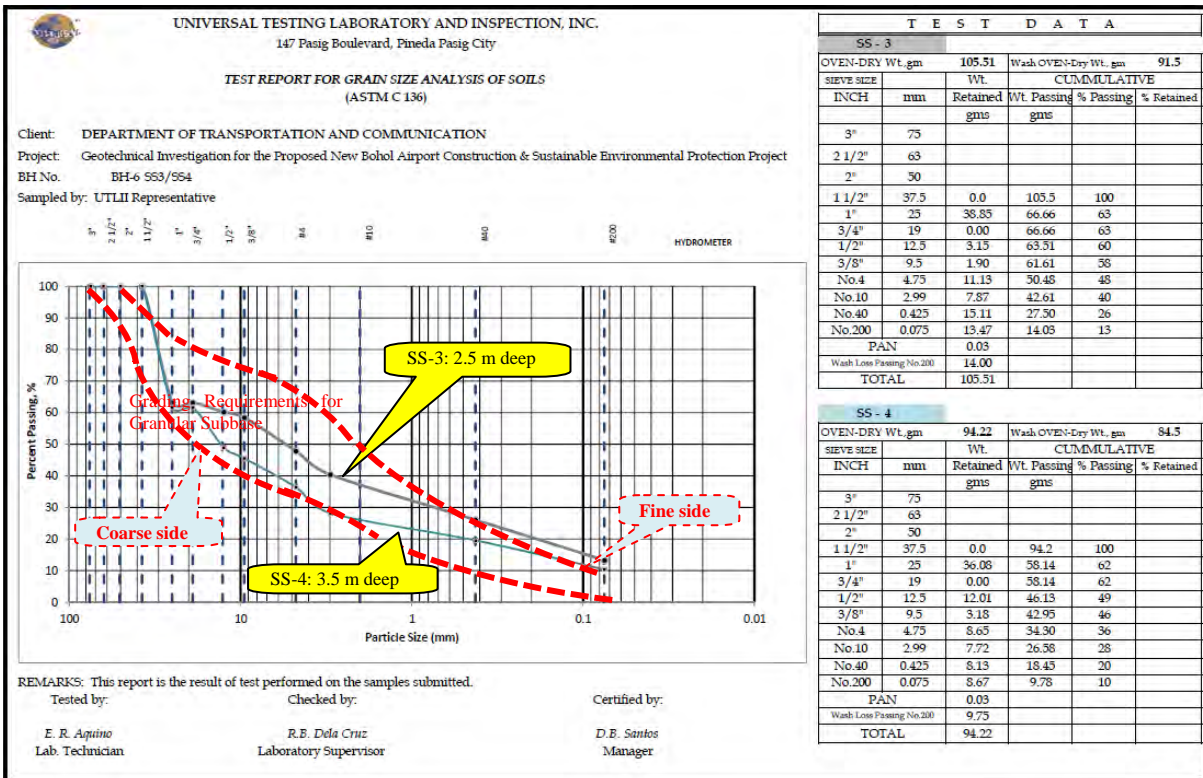
Borehole BH-6 – Access Road (Pavement Thickness: 0.5 m + Subgrade: 0.5 m)

No fine topsoil exists. No large cavity exists.

Natural soil at surface generally meets gradation of granular subbase course when blending with small amount of crashed limestone fragment.
